## **IMPORTANT SAFETY RECALL NOTICE**

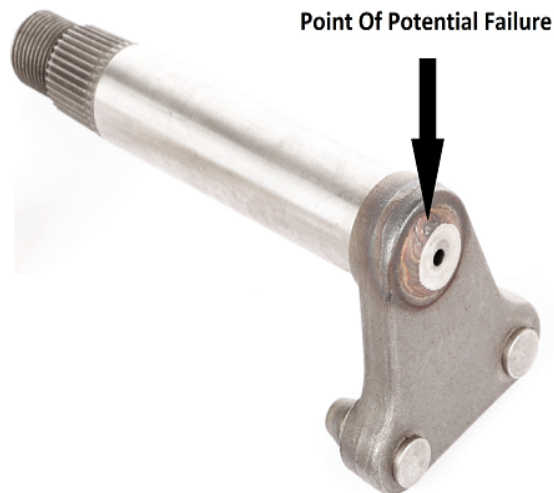
The recalled steering sector shafts are best identified by visually inspecting the outer surface of the part. The recalled sector shafts are a two-piece design featuring a splined shaft fitted at a right angle to a flat metal plate. A small weld should be visible where the shaft is pressed into the flat angle plate. Also on the recalled part, the two worm gear engaging points appear as flat, round circular surfaces on the outside of the right-angle plate. The recalled parts DO NOT have case numbers or “WAT” on the outside of the flat piece and Do Not have cooper plated engaging points. (See illustration - *to be provided*). Go to [omix-ada.com](http://omix-ada.com) & safety recall link for further help identifying these parts.

**What is the Problem?** Incomplete heat treating of the recalled parts by Omix-Ada's supplier may contribute to accelerated wear and flexing during use (or following shock loads from highway and off-road rocks and obstacles) creating an increased risk of premature failure and crash.

Omix® has sourced a replacement sector shaft for the recalled parts featuring an improved cast design. Upon owner inspection and verification of a recalled part, Omix will supply owners with an improved sector shaft replacement free of charge. Contact Omix toll-free 770/614-6101 or at: [recall@omix-ada.com](mailto:recall@omix-ada.com). You may be asked for information regarding your vehicle application, place or proof of purchase and a picture of our existing sector shaft. Please have the information available to you when you call. Replacement parts should be available at or about the time you receive this notice. If you are unable or unwilling to replace a recalled sector shaft, Omix will direct you to an authorized service center for replacement and will compensate the service center at prevailing rates for up to 2.0 hours.

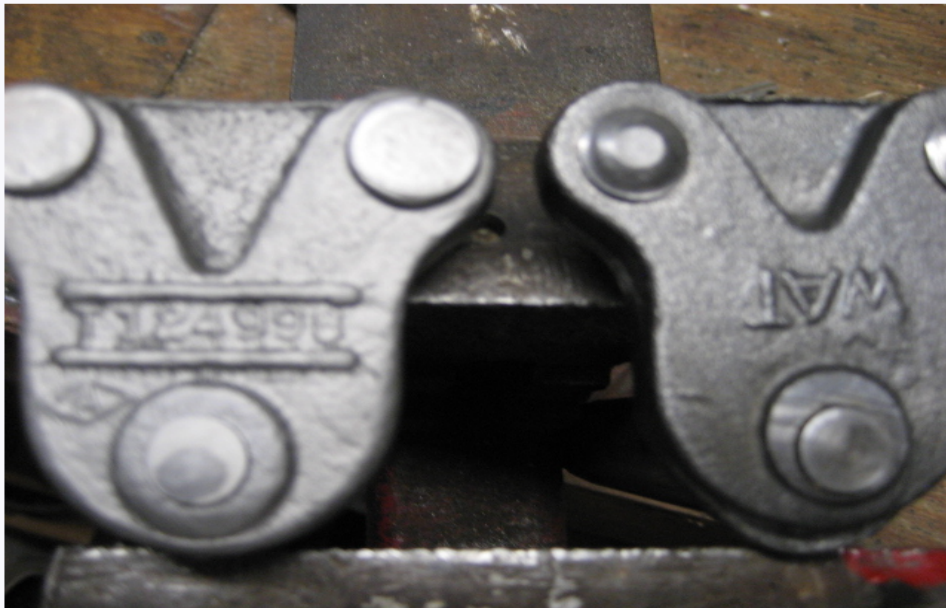
**If your sector shaft is marked as the two in this photo, they are not affected by this safety recall.**
